Sample Site, Sample Street, Anytown, UK

Professional opinion

Regulated Stone Mining summary

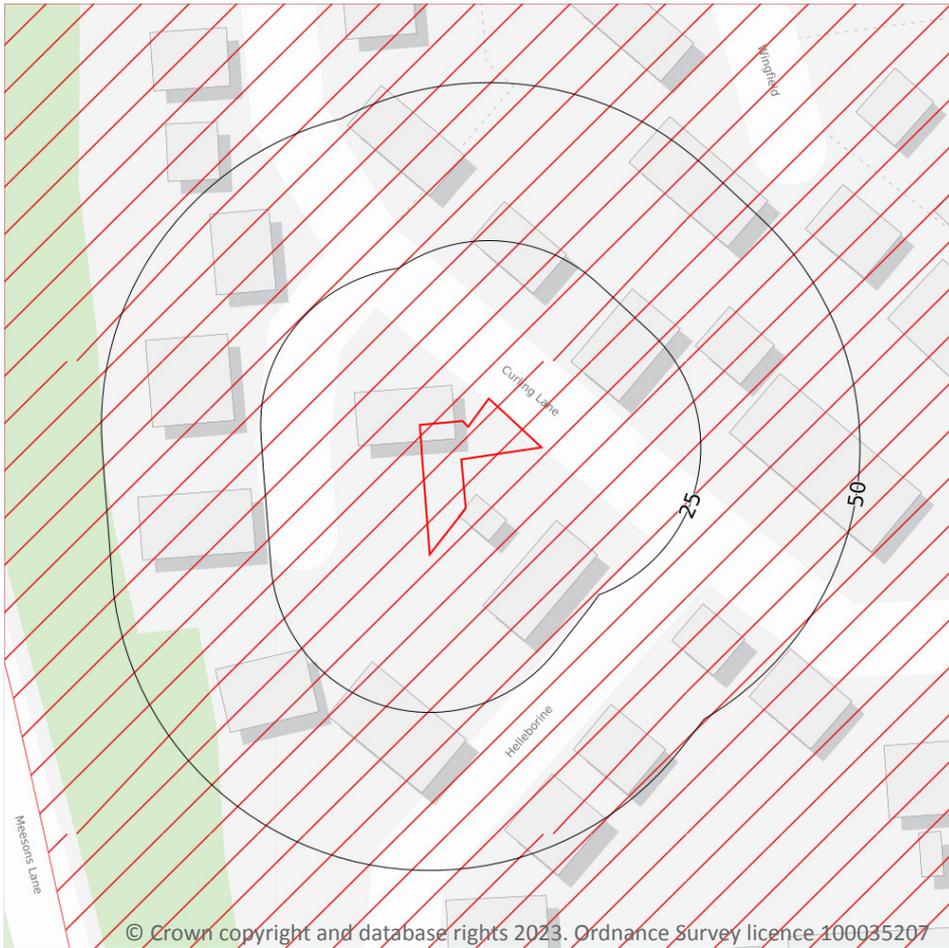
Non-coal mining / Stone mining features

Surface workings

Surface workings identified from OS, BGS Geological mapping, Lidar data, and mine plans sourced from the BGS and various collections and sources.

Location	Feature	Mineral	Mining type
On site	Quarry	Chalk	Stone

The property is recorded to lie within a former quarry. We have not confirmed the full lateral and vertical extent of the quarry and the nature of in-fill. In-fill or remnant quarry faces may be a potential settlement or subsidence risk.

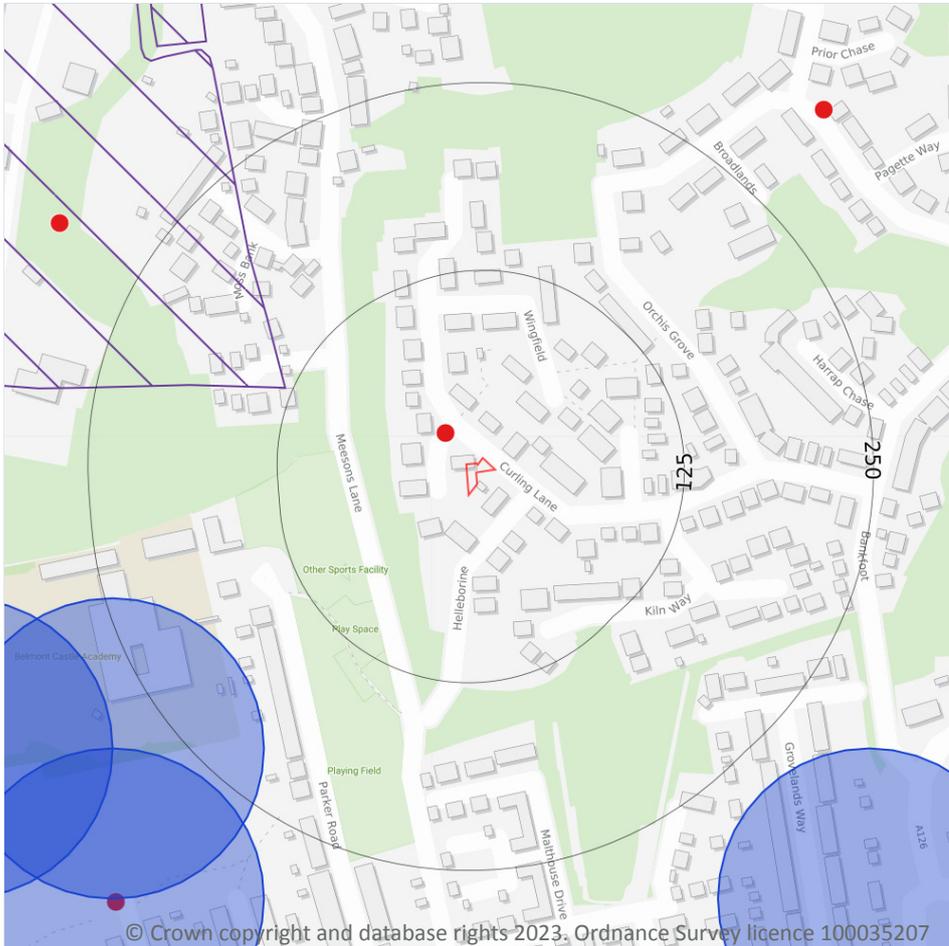
Non-coal mining / Mining records

BritPits

BritPits (an abbreviation of British Pits) is a database maintained by the British Geological Survey of currently active and closed surface and underground mineral workings. Details of major mineral handling sites, such as wharfs and rail depots are also held in the database.

Location	Details	Description
24m NW	Name: Grays Chalk Quarries Address: GRAYS, Essex Commodity: Chalk Status: Ceased	Type: A surface mineral working. It may be termed Quarry, Sand Pit, Clay Pit or Opencast Coal Site Status description: Site which, at date of entry, has ceased to extract minerals. May be considered as Closed by operator. May be considered to have Active, Dormant or Expired planning permissions by Mineral Planning Authority

Mining cavities

Industry recognised national database of mining cavities. Degraded mines may result in hazardous subsidence (crown holes). Climatic conditions and water escape can also trigger subsidence over mine entrances and workings.

Location	Mine Address	Mineral	Data source	Publisher
190m SW	Grays, Essex	Chalk	-	-

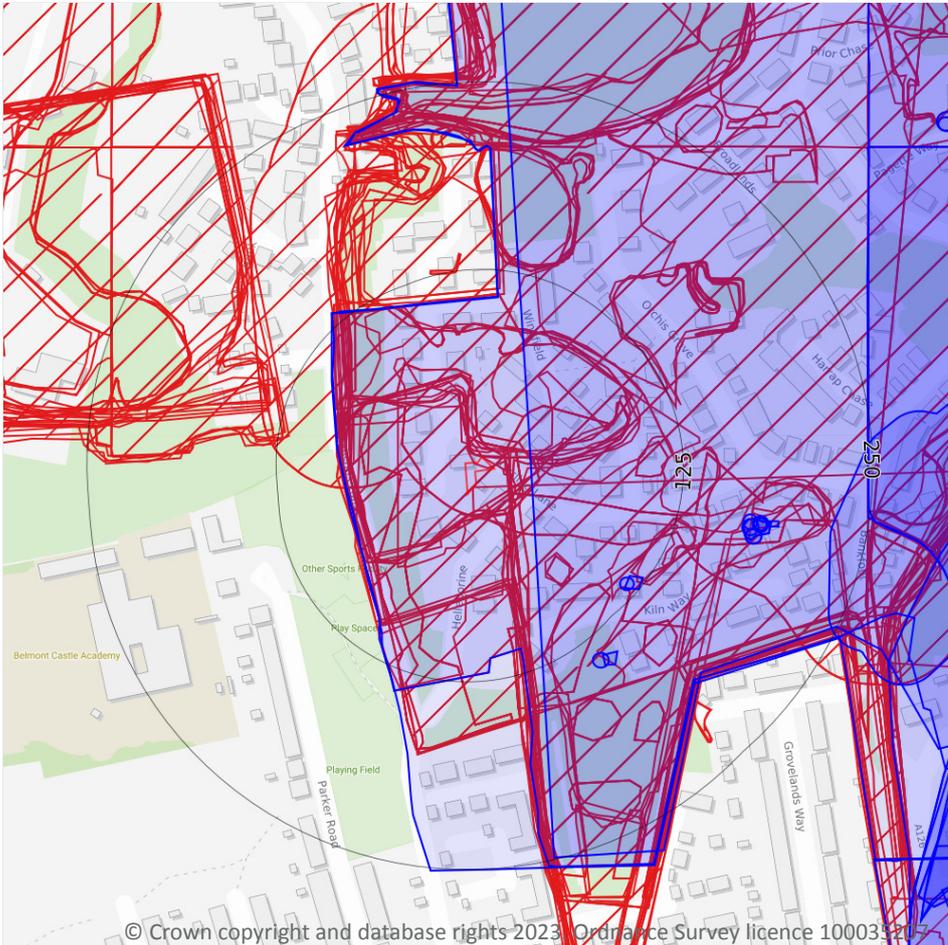
Non-coal mining / Historical features

Non-coal mining

Historical land uses identified from Ordnance Survey mapping that involved mining for substances other than coal.

Location	Land use	Date
On site	Ground Workings	1950
On site	Ground Workings	1973
On site	Quarries	1897
On site	Chalk Quarry	1920
On site	Ground Workings	1966
On site	Chalk Quarries	1950

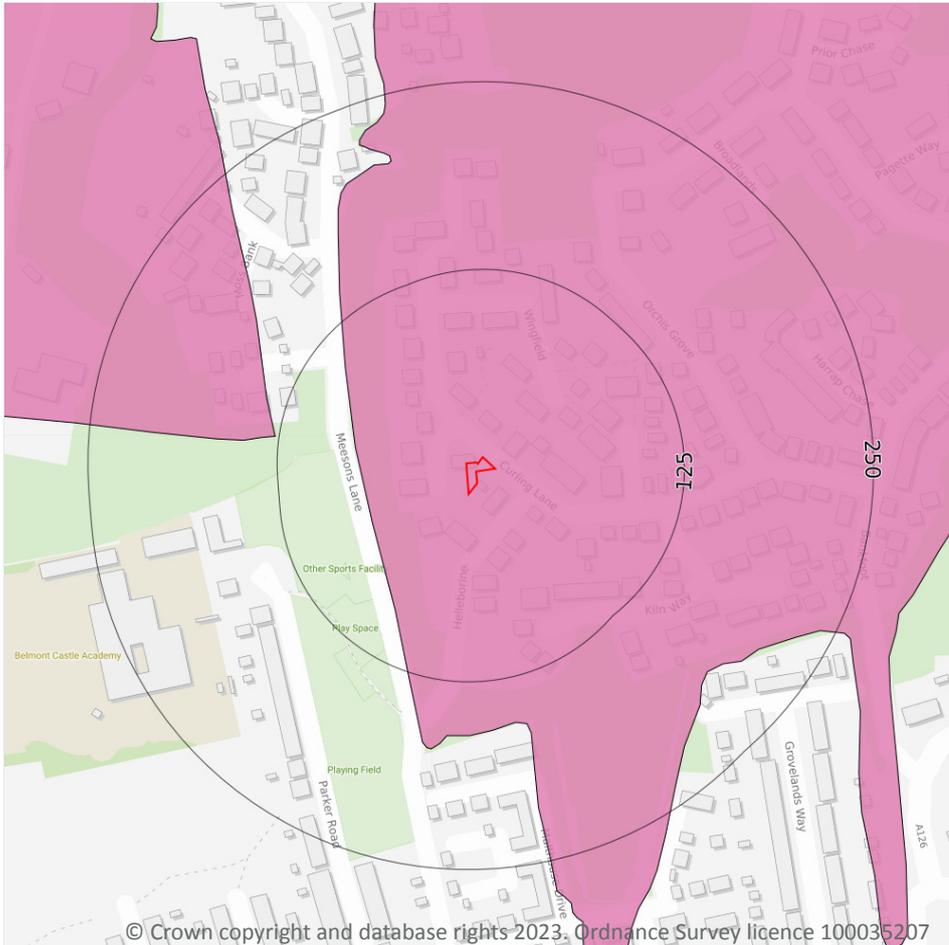
Non-coal mining / Geological features 10k

Artificial and made ground (10k)

Details of made, worked, infilled, disturbed and landscaped ground at 1:10 000 scale. Artificial ground can be associated with potentially contaminated material, unpredictable engineering conditions and instability.

Location	LEX Code	Description	Rock description
On site	WGR-UNKNOWN	Worked Ground (Undivided)	Unknown/unclassified Entry

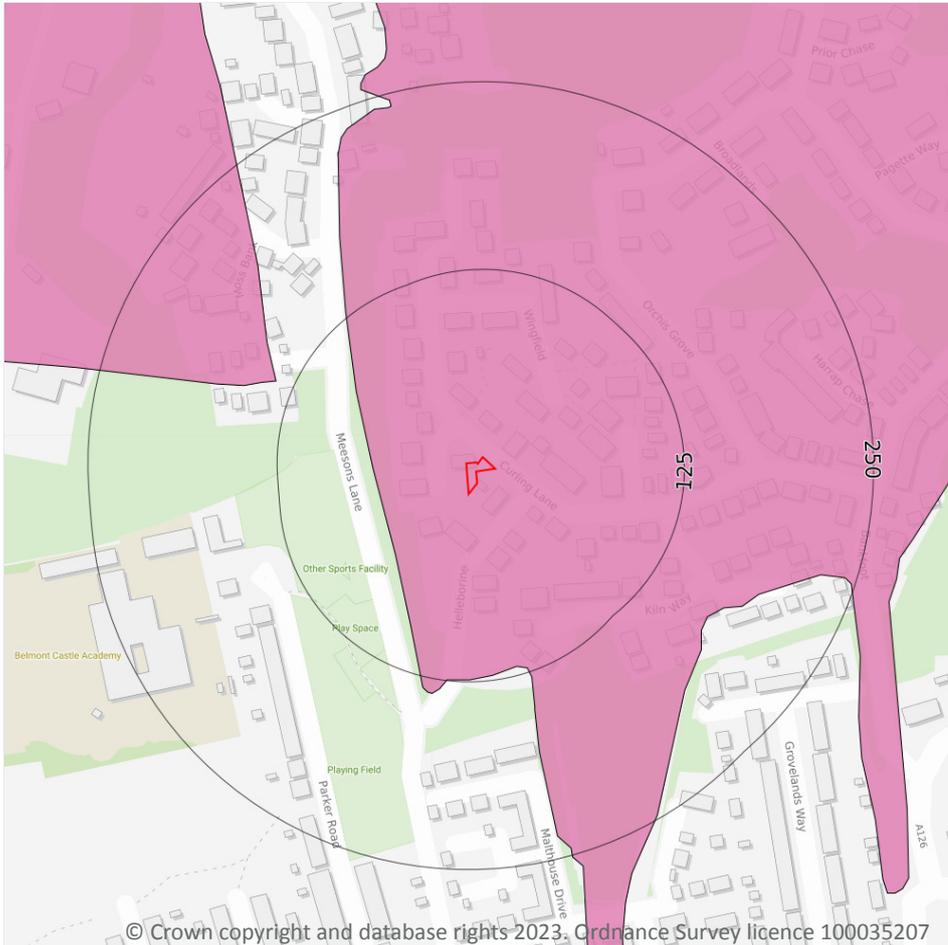
Non-coal mining / Geological features 50k

Artificial and made ground (50k)

Details of made, worked, infilled, disturbed and landscaped ground at 1:50 000 scale. Artificial ground can be associated with potentially contaminated material, unpredictable engineering conditions and instability.

Location	LEX Code	Description	Rock description
On site	WGR-VOID	WORKED GROUND (UNDIVIDED)	VOID
