### Specimen Address, Specimen Town

### **Professional opinion**

**Ref**: Siteguard-Sample **Grid ref**: 123456, 123456 **Date**: 26 November 2020

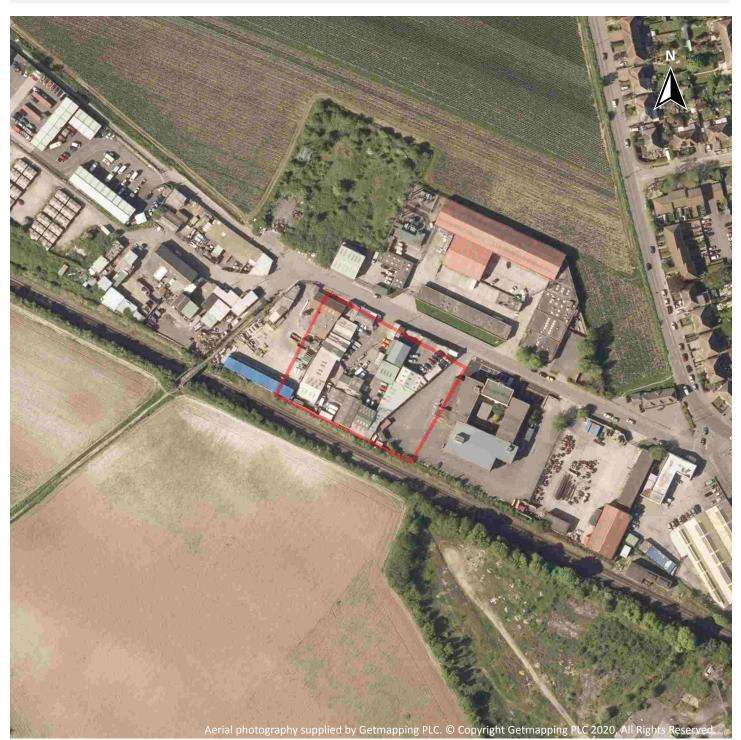
## **Recent aerial photograph**

Capture Date: 05/05/2018 Site Area: 0.54ha

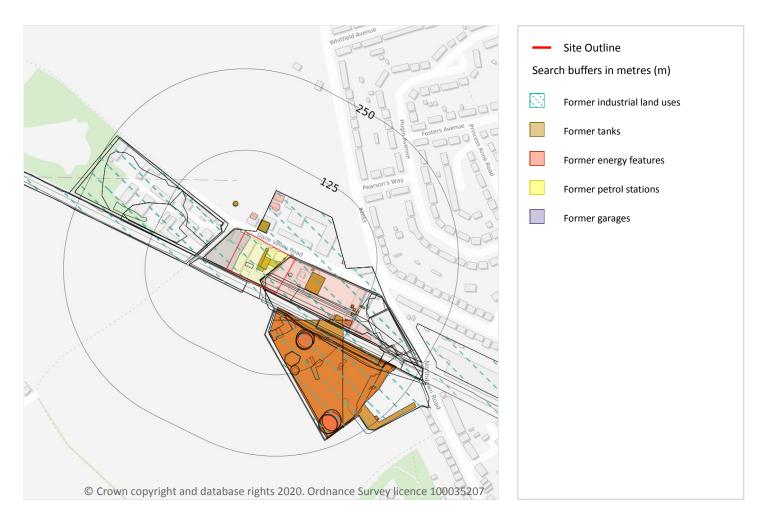
### Past land use

#### Former industrial land use (1:10,560 and 1:10,000 scale)

These historical land uses have been identified from 1:10,560 and 1:10,000 scale Ordnance Survey maps dated from the mid to late 1800s to recent times. They have the potential to have caused ground contamination. Please see the Environmental Summary to find out how these could impact the site.

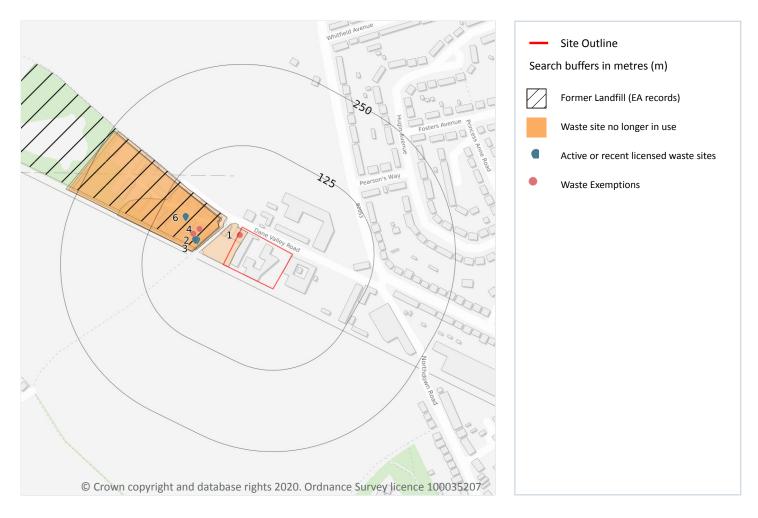
### Waste and landfill

#### Waste site no longer in use

These are records of former waste storage, treatment or transfer sites that have been identified from high detailed historical maps or Local Authority planning records. Depending on the nature of the waste that was handled and stored at these facilities, there may be a risk of ground contamination.

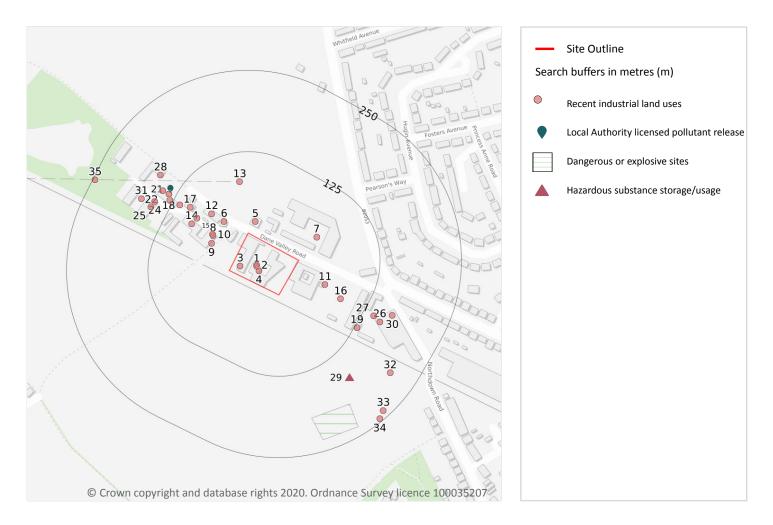
### **Current and recent industrial**

#### **Recent industrial land uses**

These records show details of businesses that have recently operated, or are currently operating in the area. Depending on the type of activities taking place, some of these businesses could present a risk of contamination.

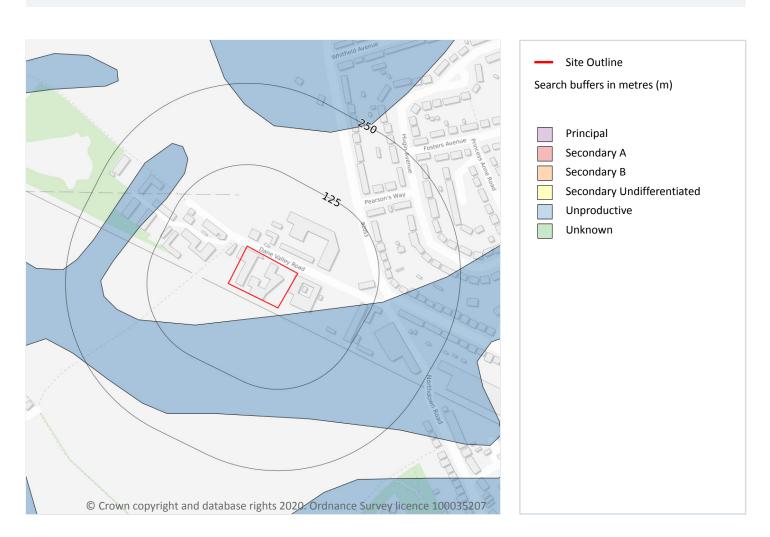
## Superficial hydrogeology

#### Aquifers within superficial geology

The Environment Agency/Natural Resources Wales and the British Geological Survey have assigned designations or types to the aquifers that exist within superficial geology. These designations reflect the importance of aquifers in terms of groundwater as a resource (eg drinking water supply) but also their role in supporting surface water flows and wetland ecosystems.

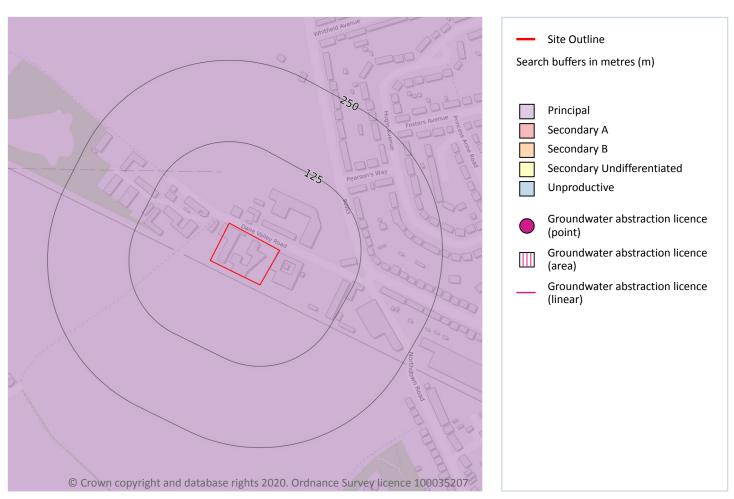
## Bedrock hydrogeology

### Aquifers within bedrock geology

The Environment Agency/Natural Resources Wales and the British Geological Survey have assigned designations or types to the aquifers that exist within bedrock geology. These designations reflect the importance of aquifers in terms of groundwater as a resource (eg drinking water supply) but also their role in supporting surface water flows and wetland ecosystems.

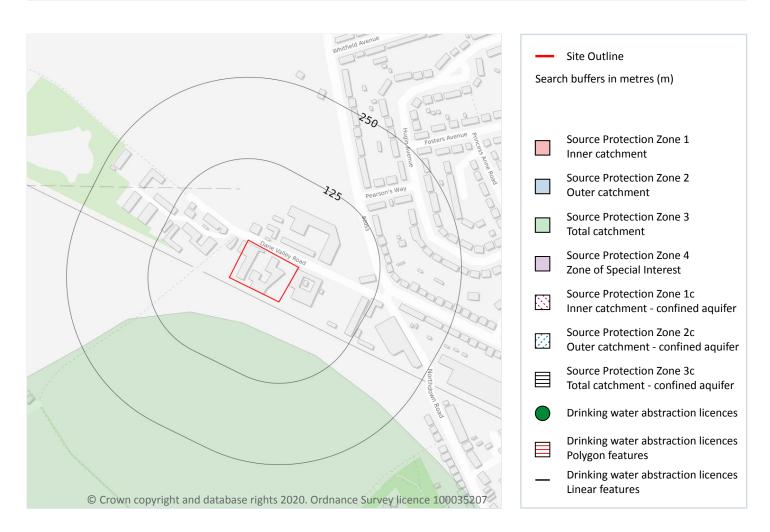
## **Source Protection Zones and drinking water abstractions**

#### **Source Protection Zones**

The Environment Agency / Natural Resources Wales has defined Source Protection Zones (SPZs) for groundwater sources such as wells, boreholes and springs used for public drinking water supply. These zones show the risk of contamination from any activities that might cause pollution in the area. The closer the activity, the greater the risk. There are three main zones (inner (SPZ 1), outer (SPZ 2) and total catchment (SPZ 3)) and a fourth zone of special interest.

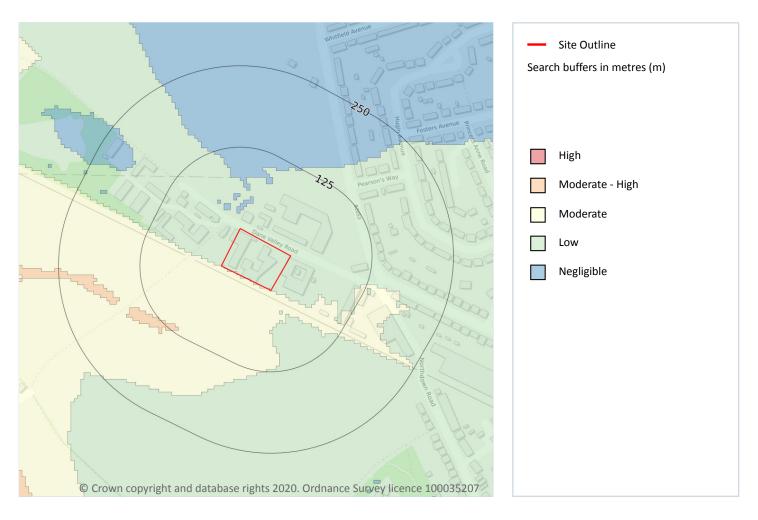
### **Groundwater flooding**

Ambiental data indicates that the property is in an area with a moderate risk of groundwater flooding. Should a 1 in 100-year groundwater flood event occur, groundwater levels may affect basement areas. Properties without basements are not considered to be at risk from this level of groundwater flooding.

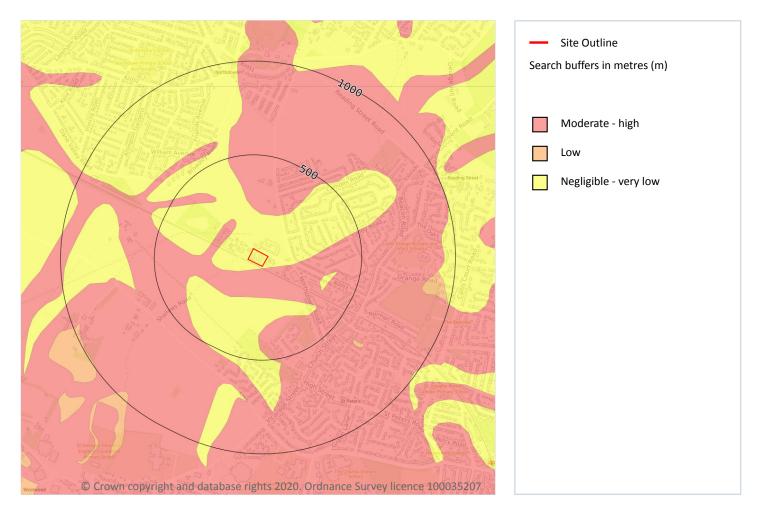
### Natural ground subsidence

#### Natural ground subsidence

The property, or an area within 50m of the property, has a moderate to high potential for natural ground subsidence. This rating is derived from the British Geological Survey's GeoSure database, and is based upon the natural qualities of the geology at the site rather than any historical subsidence claims or events. Additionally, this data does not take into account whether buildings on site have been designed to withstand any degree of subsidence hazard.

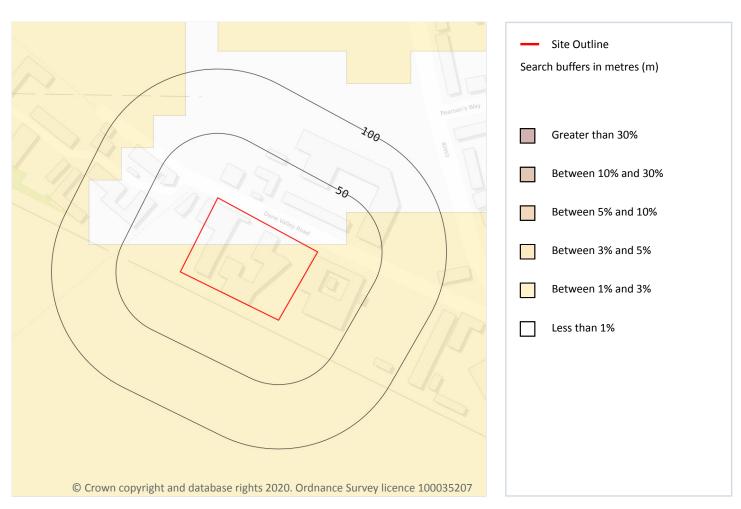
### Radon

The property is in a radon affected area, meaning the area has a general radon level above the radon Action Level. In order to determine if there is a problem at your property, a radon measurement in the building must be taken. Access to a testing service and further information on radon is available from Public Health England (PHE) or <u>www.ukradon.org</u>. Radon is a colourless, odourless radioactive gas present in all areas of the United Kingdom, usually at levels that pose a negligible risk. However, the property is situated in an area where levels of radon can be much higher and pose a health risk. High levels of radon can cause lung cancer, particularly for smokers and ex-smokers. The higher the level and the longer the period of exposure, the greater the risk. If you are buying a currently occupied property in a radon affected area, ask the present owner whether radon levels have been measured and, if they have, whether the results were above the radon Action Level. If so, what remedial measures were installed, were radon levels re-tested and did the re-testing confirm the measures have been effective.
